**Flood Control Project Maintenance
Levee Inspections**

Maintenance Issue Types Only, Levee Inspection Report By Mile - Spring 2017

Sutter Maintenance Yard Murphy Slough at M&T Ranch

Waterway	Bank	Unit Miles	Inspection Start/End	Inspector
Unit No. 01 Murphy Slough at M&T Ranch	Left	0.83	04/21/2017 04/21/2017	Bob Duffey

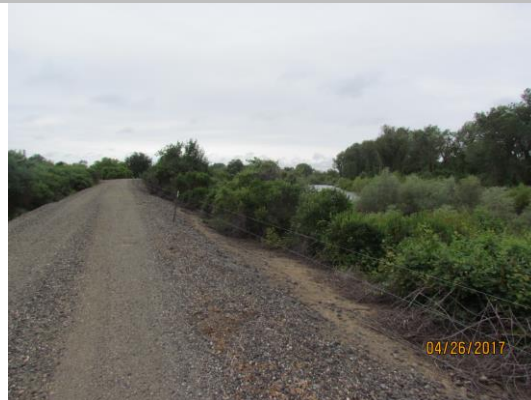
Photo 1 of 1 : SP_2017_ST0014_372_1_20170426_00002.jpg

LM Start	0.00	Rating **	M	Issue No.	1
LM End	0.09	Issue Type +	Ma	Location *	WS
Category	Earthen Levee			GPS Latitude/Longitude	
				Start	End
Item	Vegetation			39.667534 °	39.666836 °
				-121.959612 °	-121.960897 °
DWR ID	DWR_NA0014_01_s_2012_1				
Comment Code					
V4 : Elderberries are blocking visibility and flood fight capability.					
Inspector Comment

View of the elderberries along the waterside toe.

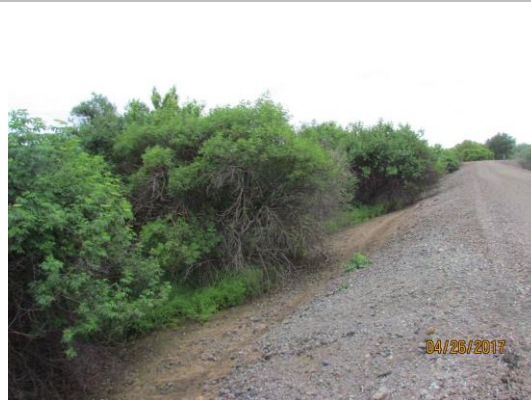
Photo 1 of 1 : SP_2017_ST0014_372_4_20170426_00001.jpg

LM Start	0.00	Rating **	M	Issue No.	4
LM End	0.09	Issue Type +	Ma	Location *	LS
Category	Earthen Levee			GPS Latitude/Longitude	
				Start	End
Item	Vegetation			39.667708 °	39.666983 °
				-121.959817 °	-121.960997 °
DWR ID	DWR_NA0014_01_s_2012_4				
Comment Code					
V4 : Elderberries are blocking visibility and flood fight capability.					
Inspector Comment

View of the elderberries along the landside toe.

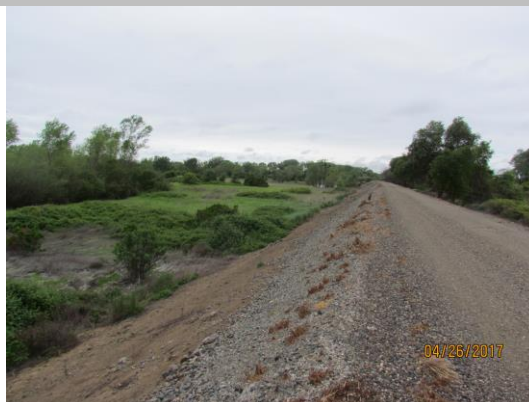
Photo 1 of 1 : SP_2017_ST0014_372_5_20170426_00003.jpg

LM Start	0.09	Rating **	A	Issue No.	5
LM End	0.83	Issue Type +	Ma	Location *	LS
Category	Earthen Levee			GPS Latitude/Longitude	
				Start	End
Item	Vegetation			39.666836 °	39.670688 °
				-121.960897 °	-121.970493 °
DWR ID	DWR_ST0014_01_s_2017_5				
Comment Code					
V1 : Control annual grass and weeds on the levee slopes and easements.					
Inspector Comment

View of all vegetation removed from the landside toe.

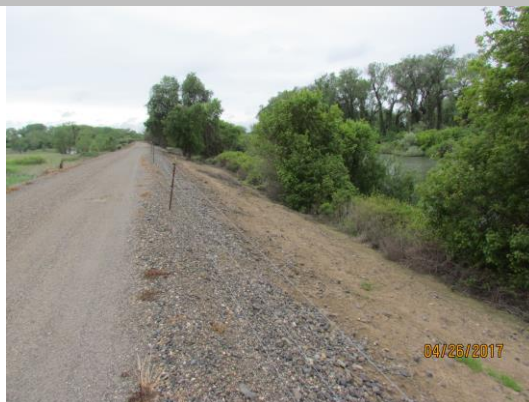
Photo 1 of 1 : SP_2017_ST0014_372_7_20170426_00004.jpg

LM Start	0.09	Rating **	A	Issue No.	7
LM End	0.83	Issue Type +	Ma	Location *	WS
Category	Earthen Levee			GPS Latitude/Longitude	
				Start	End
Item	Vegetation			39.666836 °	39.670695 °
				-121.960897 °	-121.970475 °
DWR ID	DWR_ST0014_01_s_2017_7				
Comment Code					
V1 : Control annual grass and weeds on the levee slopes and easements.					
Inspector Comment

View of all vegetation removed from the waterside toe.
